## RESPONSE TO SUDS

Planning Application: Land North of Taylors Farm

Application Reference: UTT/25/2786/OP

### **TSAG Review of Land North of Taylors Farm 07/09/2024 & 08/09/2024 submitted for Reg 18**

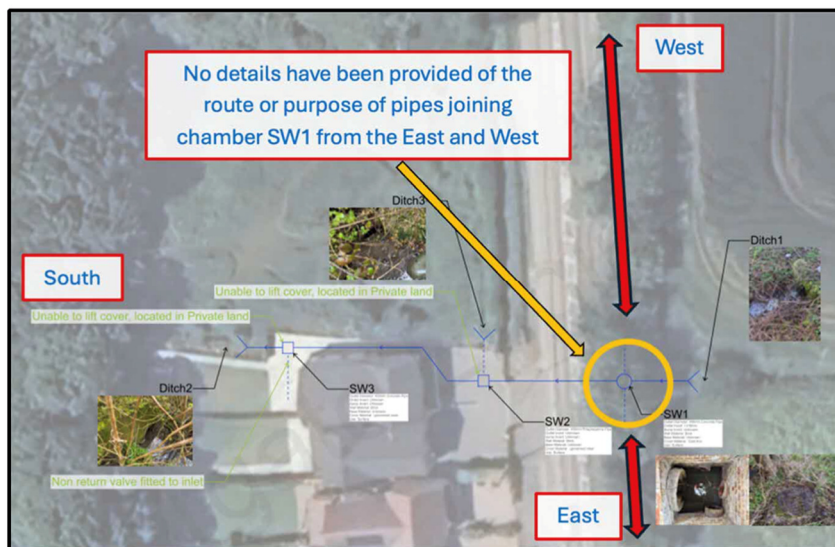
Picture 2

Extract from TSAG Dec 2025 comments detailing the SSFRA CCTV report which ignores specific details regarding the culverts East and West of the inspection Chamber indicated in the picture below. No further evidence has been supplied by the Developer.

Further investigation of the roadside ditch and Highway Drains connections are required.

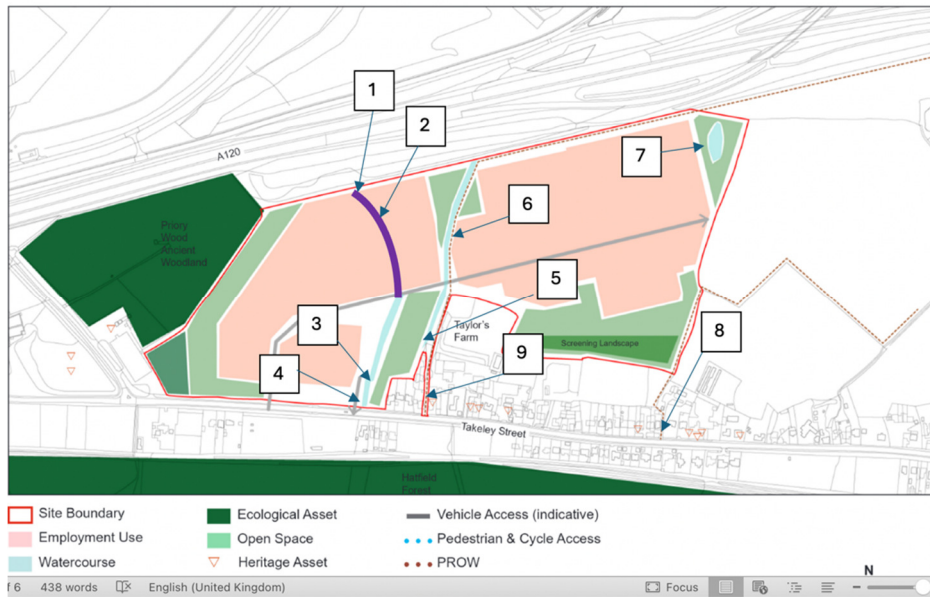
Picture 3 Original diagram from South Uttlesford Site Development Templates

1. Inaccurate length of western watercourse. Actual length highlighted in purple.
2. Location of culvert outfall on western watercourse, arriving from north east angle. Length unknown, source unknown. Culvert diameter approximately 6 inches. Depth of brook approx. 6 foot. Evidence of old tress growing within brook to prove this is not a recently dug ditch.

3. Western watercourse culvert, approx. 5m in length presumably to allow tractors to cross. Modern, brick wall and concrete culvert.
4. Culvert from Western watercourse passing under B1256. Culvert diameter approximately 18 inches. Modern construction, brick wall surround.

5. Culvert from Eastern watercourse passing under B1256. Culvert diameter approximately 18 inches. Modern construction, brick wall surround. 2 additional culverts of modern plastic construction, unknown sources.

6. Eastern watercourse culvert, approx. 5m in length presumably to allow tractors to cross. Older style, made with timber.
7. Watercourse does not exist in the north-eastern boundary (although as this drawing is a future plan it may be part of their plans to have a pond here as the land does bank down in this section).

8. Depth of both watercourses approximately 6ft throughout.

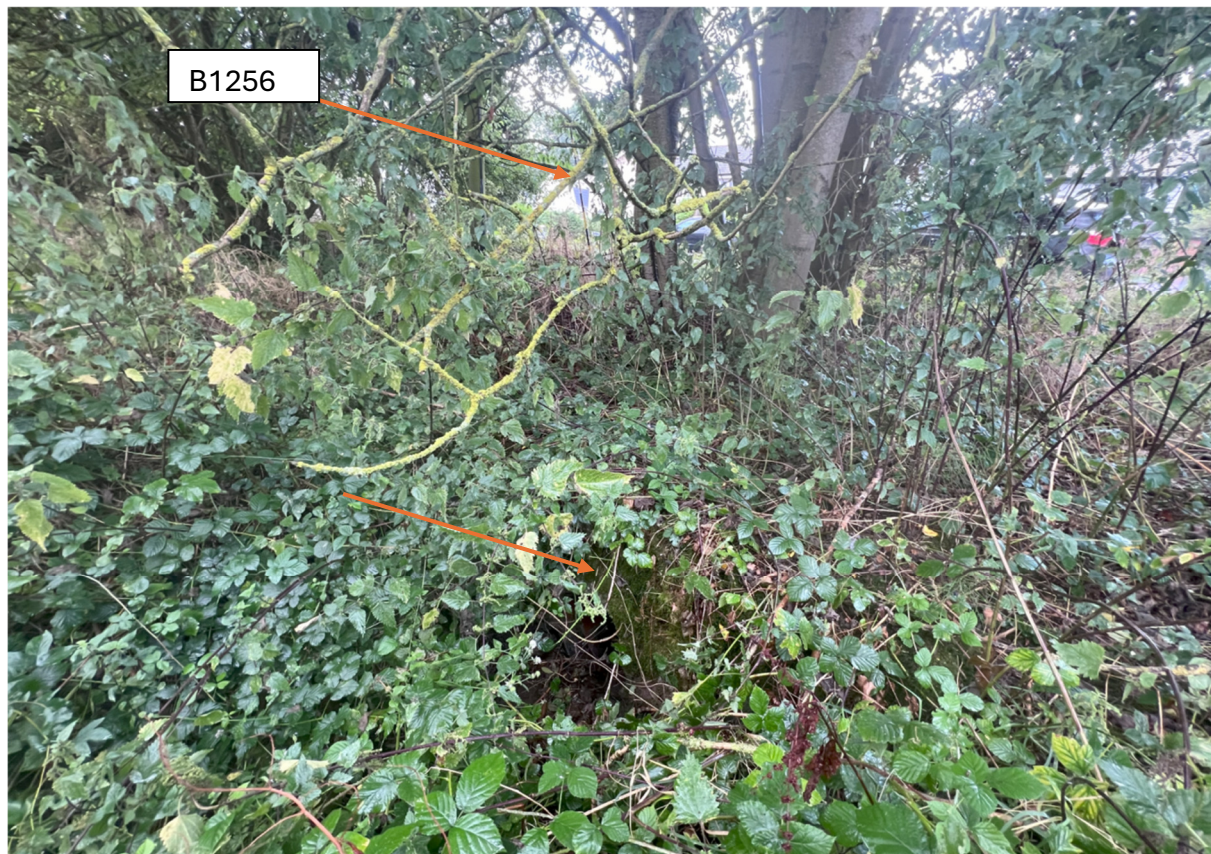
Picture 4 **Culvert from Western watercourse passing under B1256?**  
**(Location 4 on diagram)?**

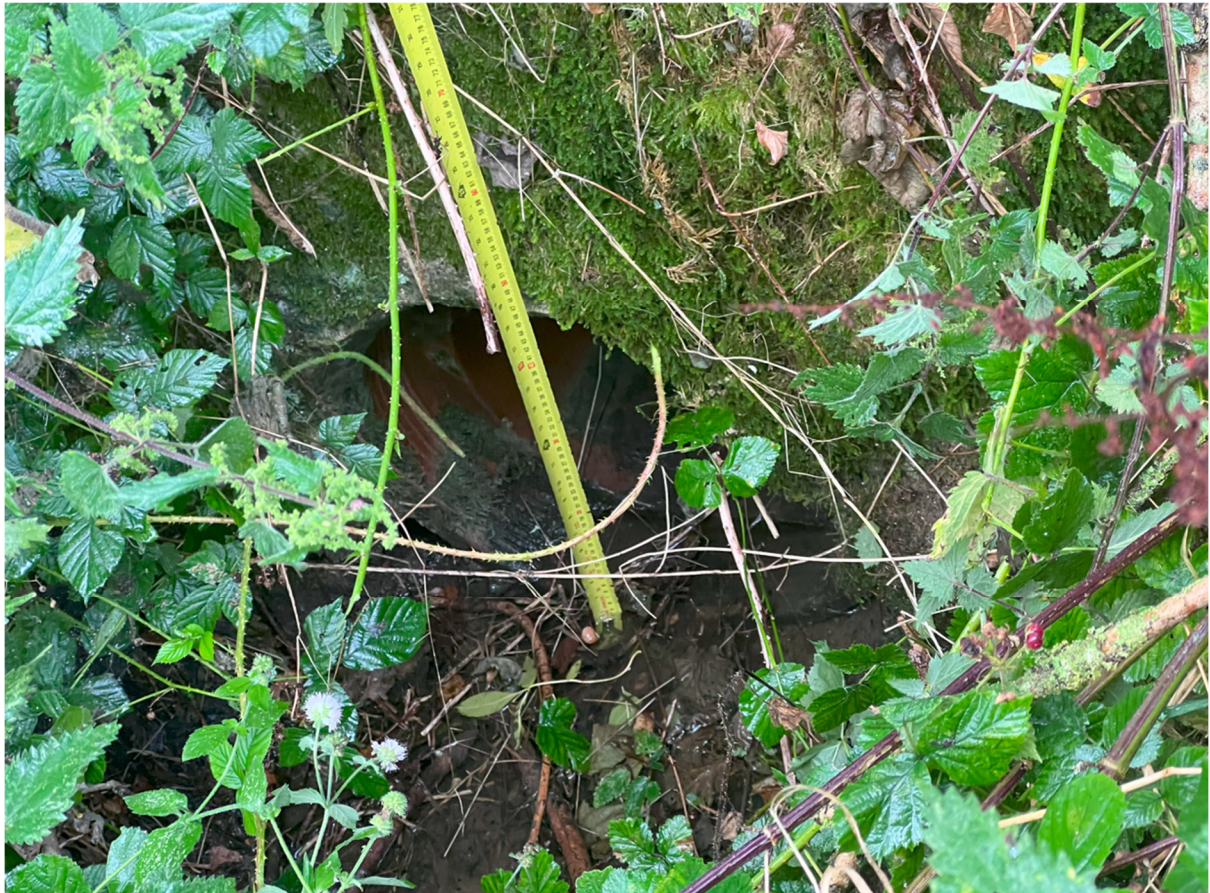
Picture 5 **Close up image of Culvert from Western Watercourse passing under B1256 (Location 4 on diagram)**<sup>2</sup>

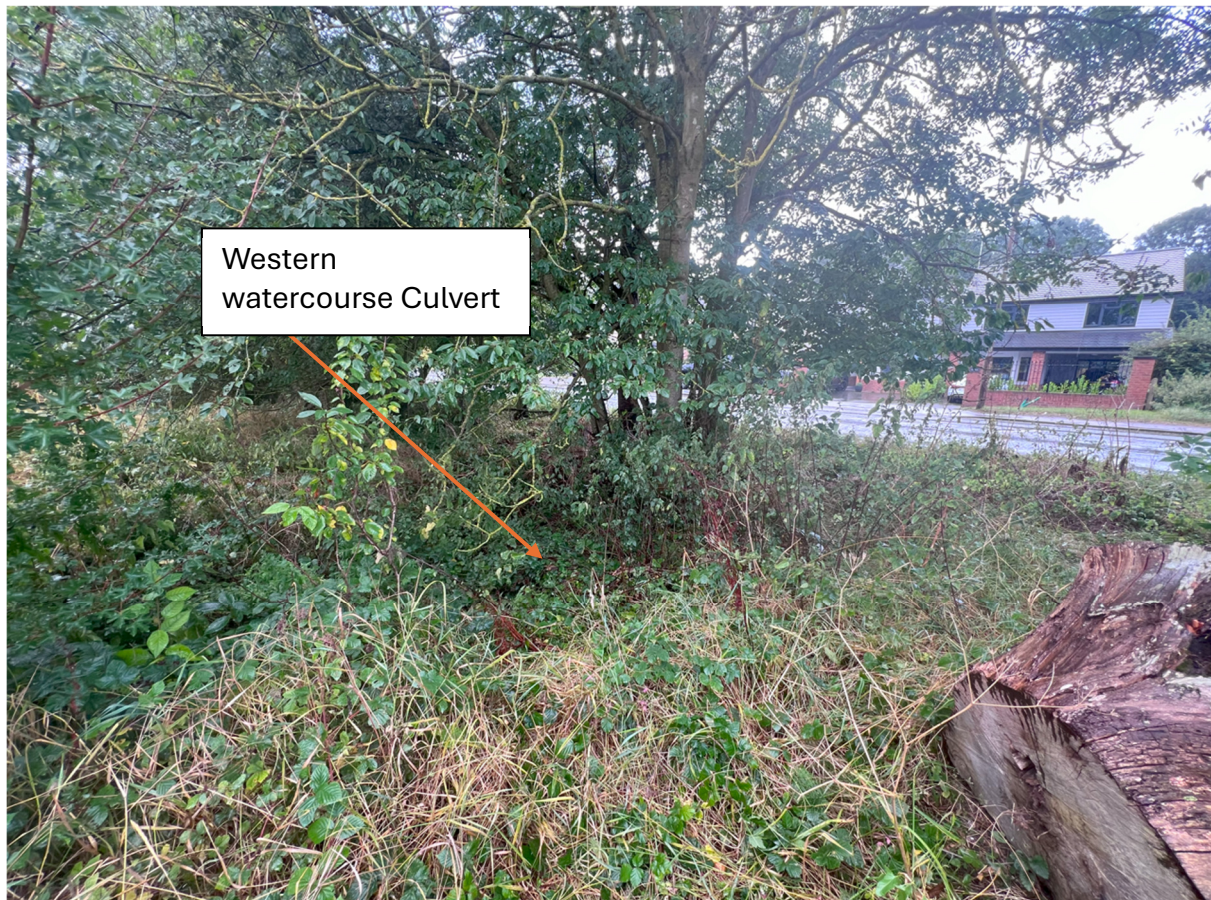
Picture 6 **Location of Culvert from Western Watercourse passing under B1256?**  
**(Location 4 on diagram)?**

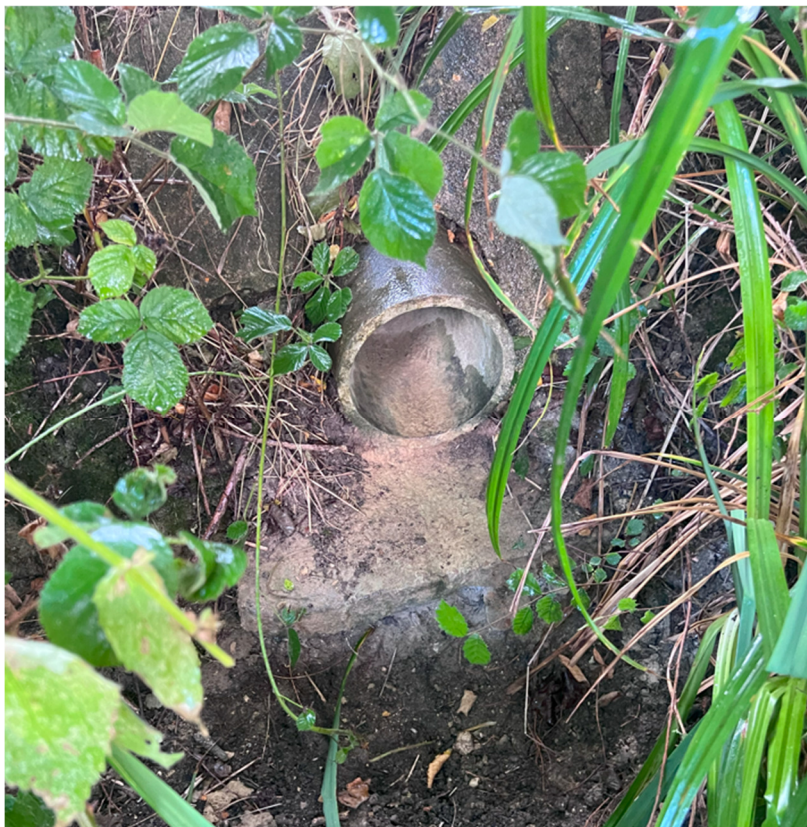
Picture 7 **Culvert outfall on western watercourse, arriving from north east angle?**  
**(Location 6 on diagram)?**

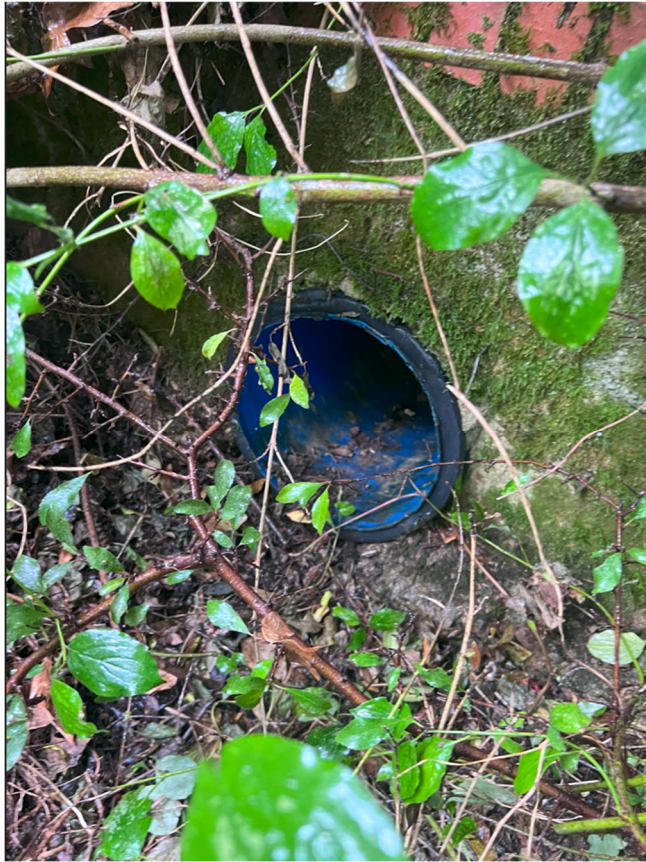
Picture 8 **Culvert from Eastern Watercourse passing under B1256**  
**(Location 5 on diagram)**

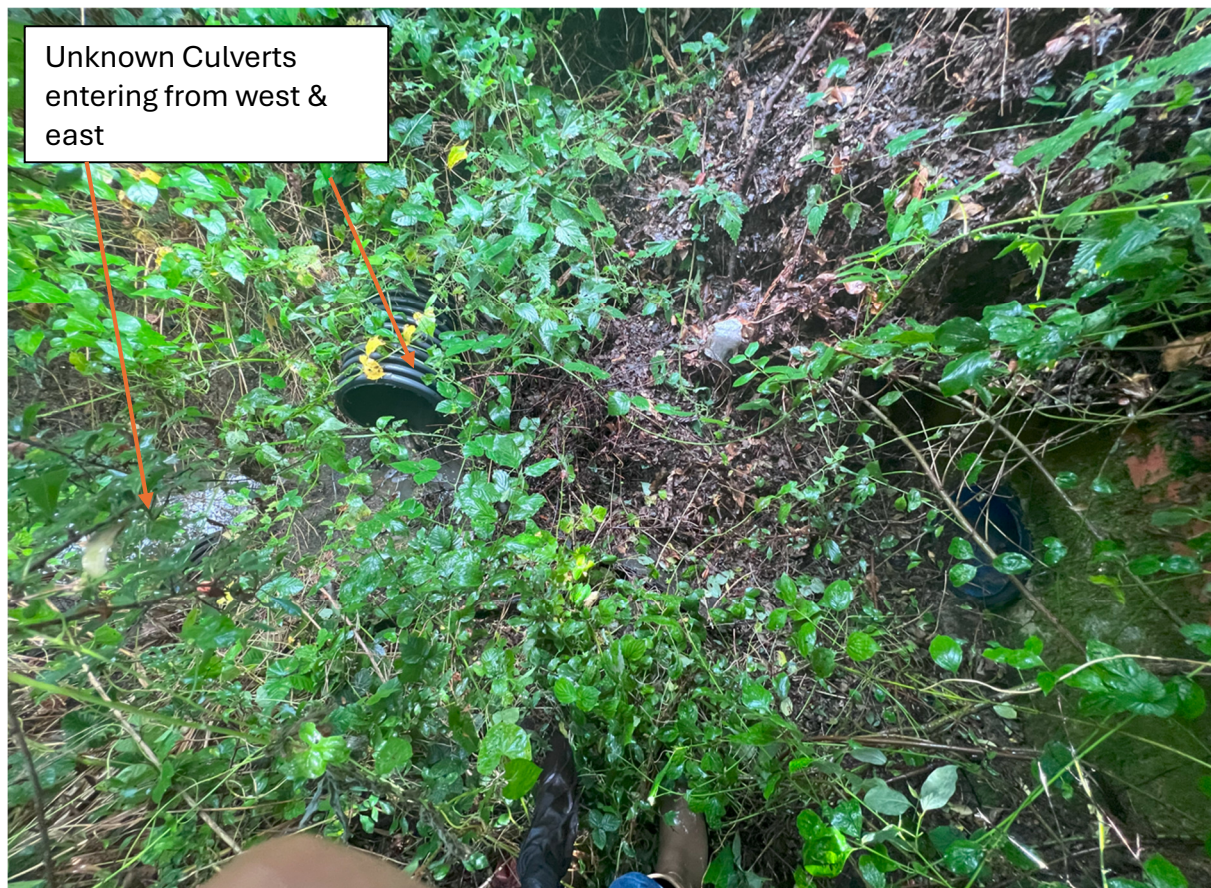
Picture 9 **3 x Culverts at Eastern Watercourse**  
**(Location 5 on diagram)**

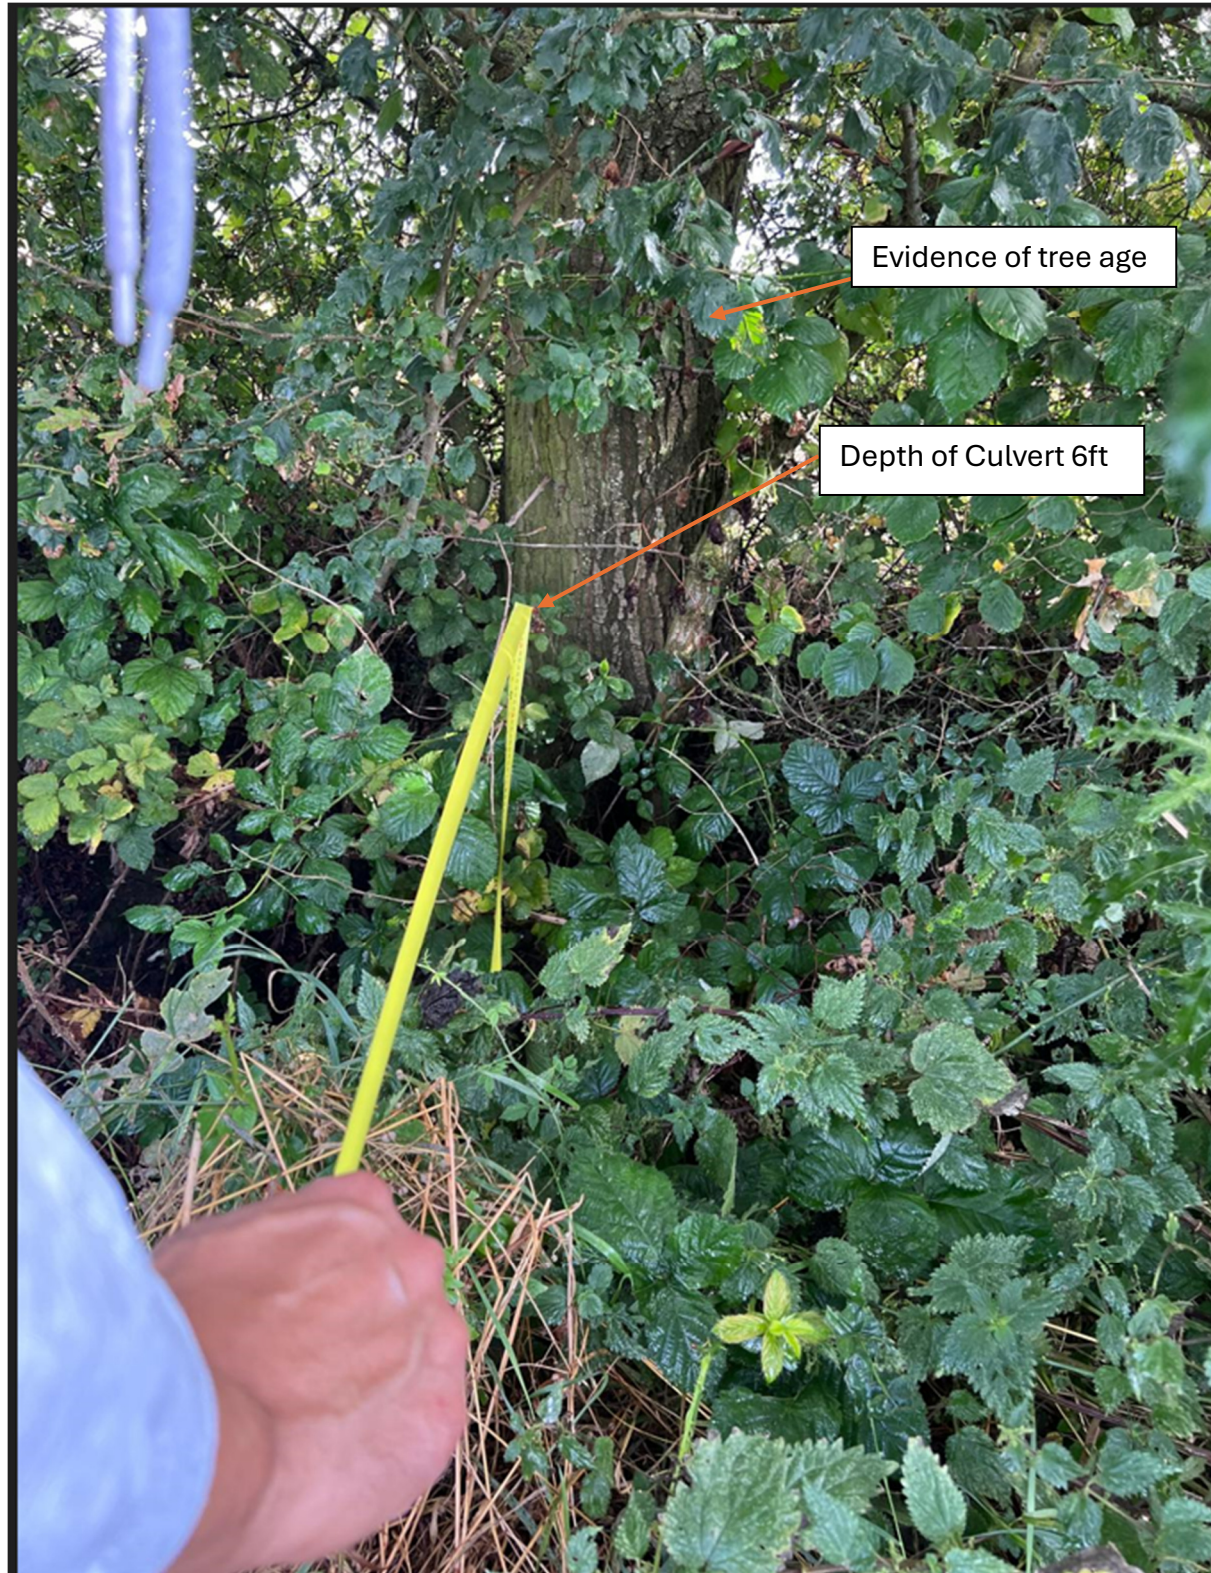
Picture 10 **Culvert outfall on Western watercourse (location 2 on diagram), arriving from north east angle** Length unknown, source unknown? **Culvert diameter approximately 6 inches** Depth of brook approx 6 foot? **Evidence of old tress growing adjacent to brook demonstrate this is not a recently dug ditch?**

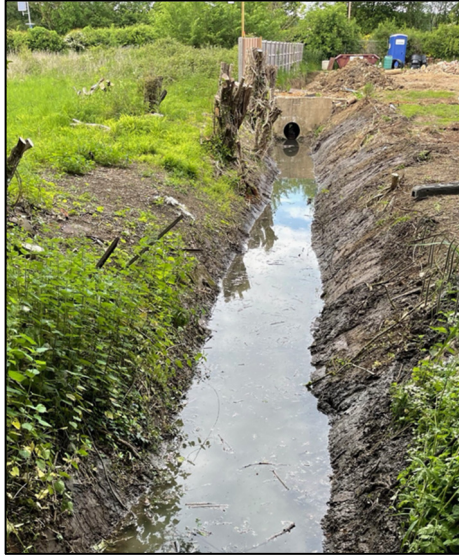
Picture 11 Shermore Brook flow from the site as it exits from under third party land known as ‘Deacons’

Whilst the Developer has stated that maintenance arrangements will be in place and their CCTV has identified potential existing maintenance needs, they have no right of access to an essential part of the drainage system. Shermore Brook is culverted under third party owned land immediately exiting the site ie the highway, a private residence and the Flitchway. They CANNOT meet the requirements of the NPPF and have not proven otherwise.

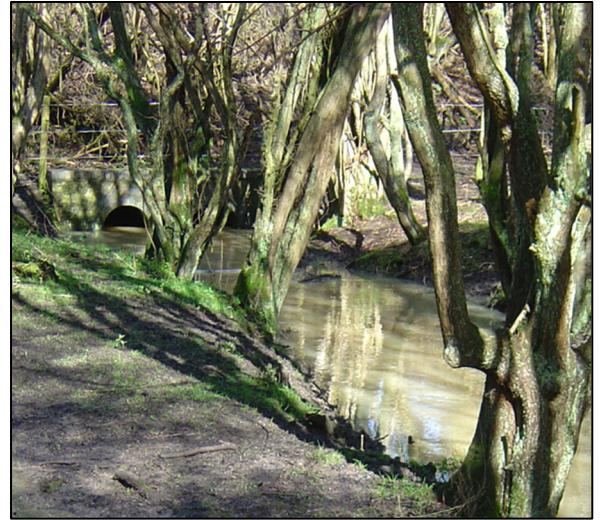
Picture 12 Shermore Brook flow at the point it enters Hatfield Forest from below the Fritchway

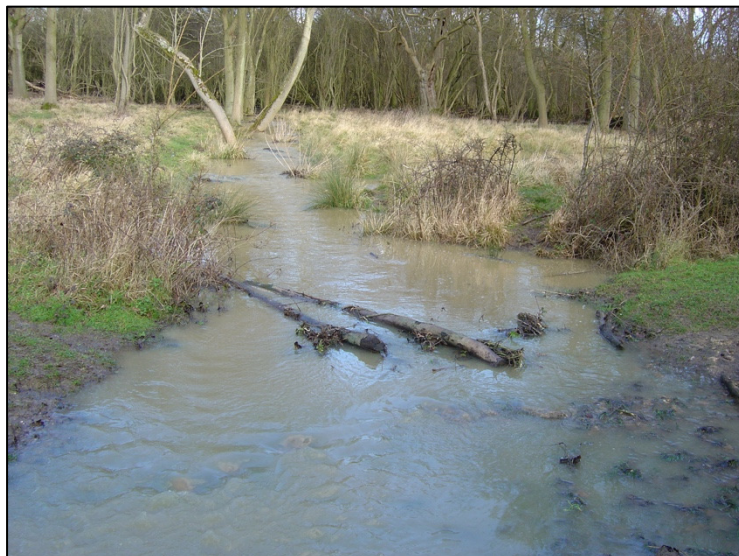
Picture 13 Shermore Brook approx 50m within the Northern edge of Hatfield Forest. Water flowing from the culvert under the Fritchway and the B1256. As evidenced the Brook takes **significant** flows from the site during wet weather. These are essential to feed Hatfield Forest (SSSI) Lake.
